***Conservation
Assessment of the
Joachim De Brum
House, Likiep Atoll,
Republic of the
Marshall Islands***

by
Jon O'Neill &
Dirk H.R. Spennemann

THE JOHNSTONE CENTRE
REPORT N° 151

***Conservation Assessment of the
Joachim De Brum House, Likiep Atoll
Republic of the Marshall Islands***

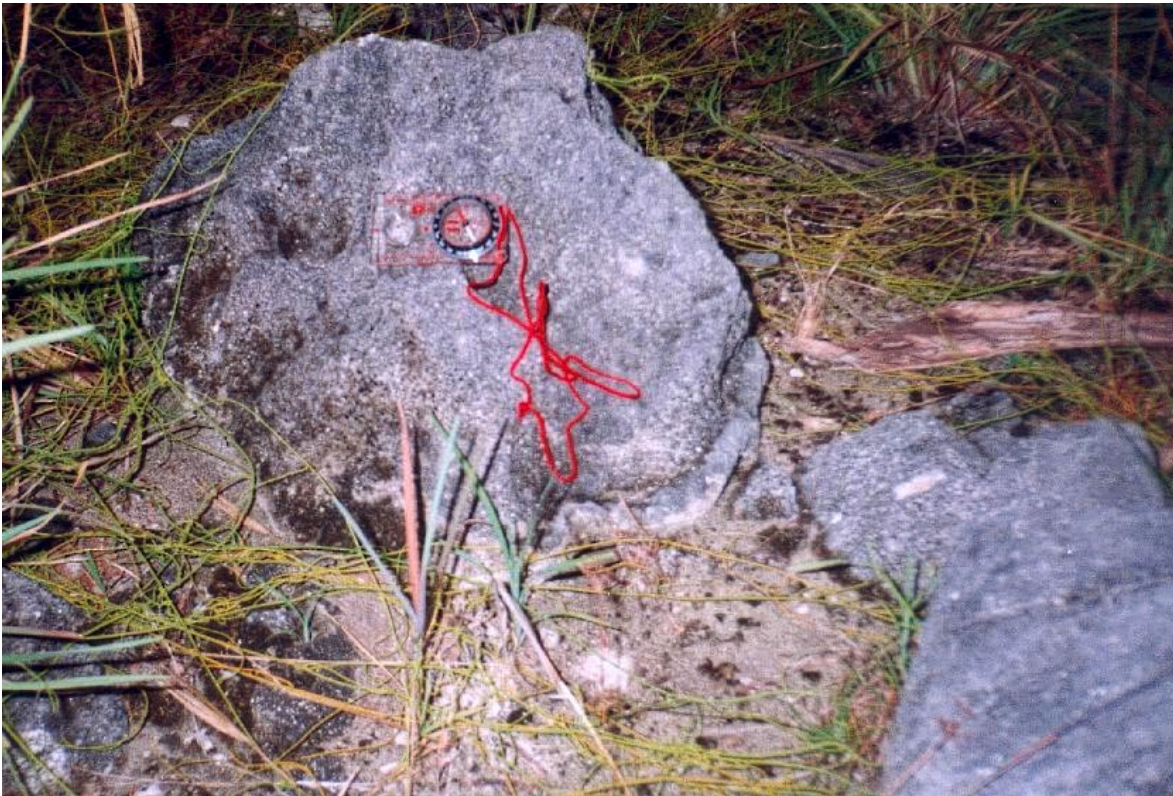
A small cemetery located on the edge of the lagoon southwest of Likiep village is endangered by erosion and some graves close to the lagoon are subsiding. Evidence of oceanic inundation includes large coral boulders (Figure 3) that cover the southwestern section of the island in particular and a strand wall. Other surface features such as disused taro pits are reported

Figure 3 : Approximately 50 cm in diameter, this coral boulder is one of thousands torn from the fringing reef (up to 150 metres off shore) and transported more than 100 metres inland by the mid-nineteenth century typhoon.

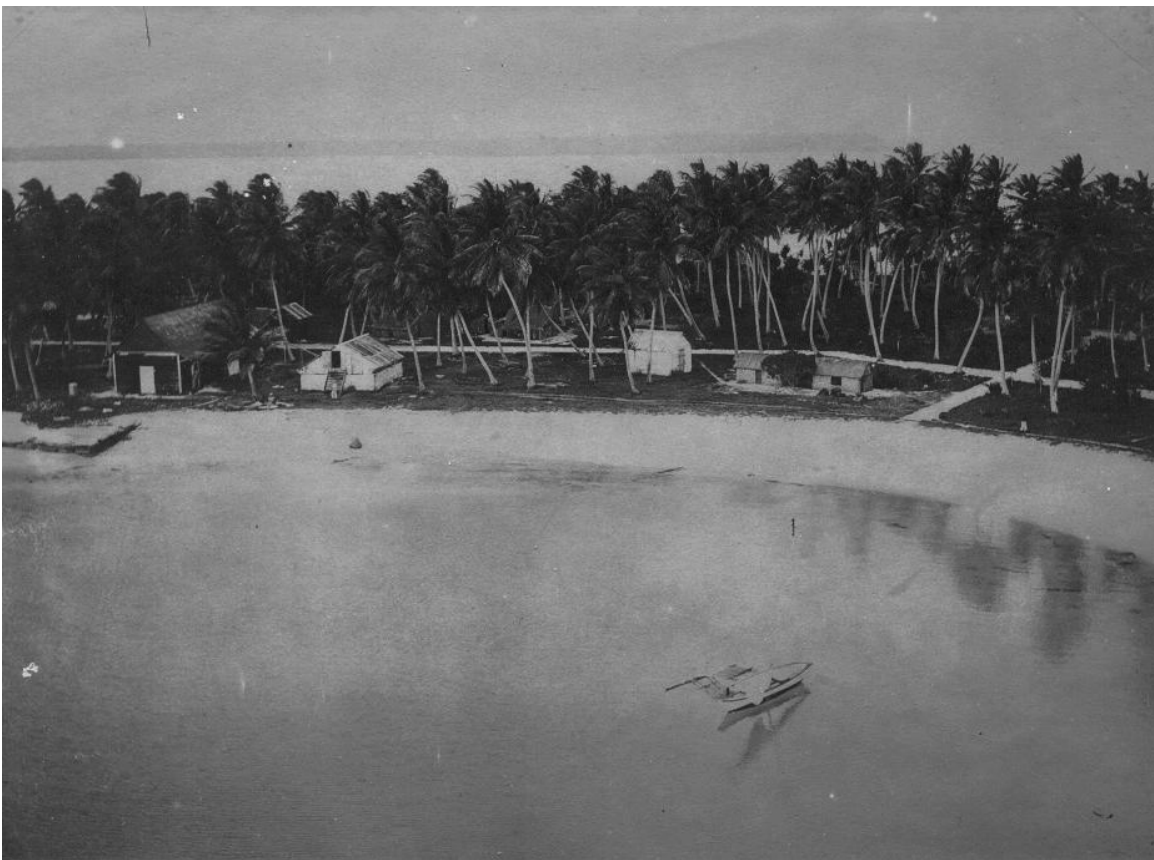
Figure 5 : Likiep Cove, c. 1910 looking east across the island to the open ocean; Photo: De Brum Collection, Alele Museum, Majuro; with permission Leonard De Brum

This first period extends from the acquisition of Likiep Atoll to the transfer of business control to Joachim De Brum and William Capelle, sons of José and Adolph, and through their mothers, both bona fide Marshall Islanders. Figure 5 is one of several thousand photographs taken by Joachim De Brum. It shows neat coral pathways, A. Capelle & Co offices, the ‘Spanish’ cistern and dock, and other buildings that were constructed during this period as Likiep was transformed physically, economically and socially.

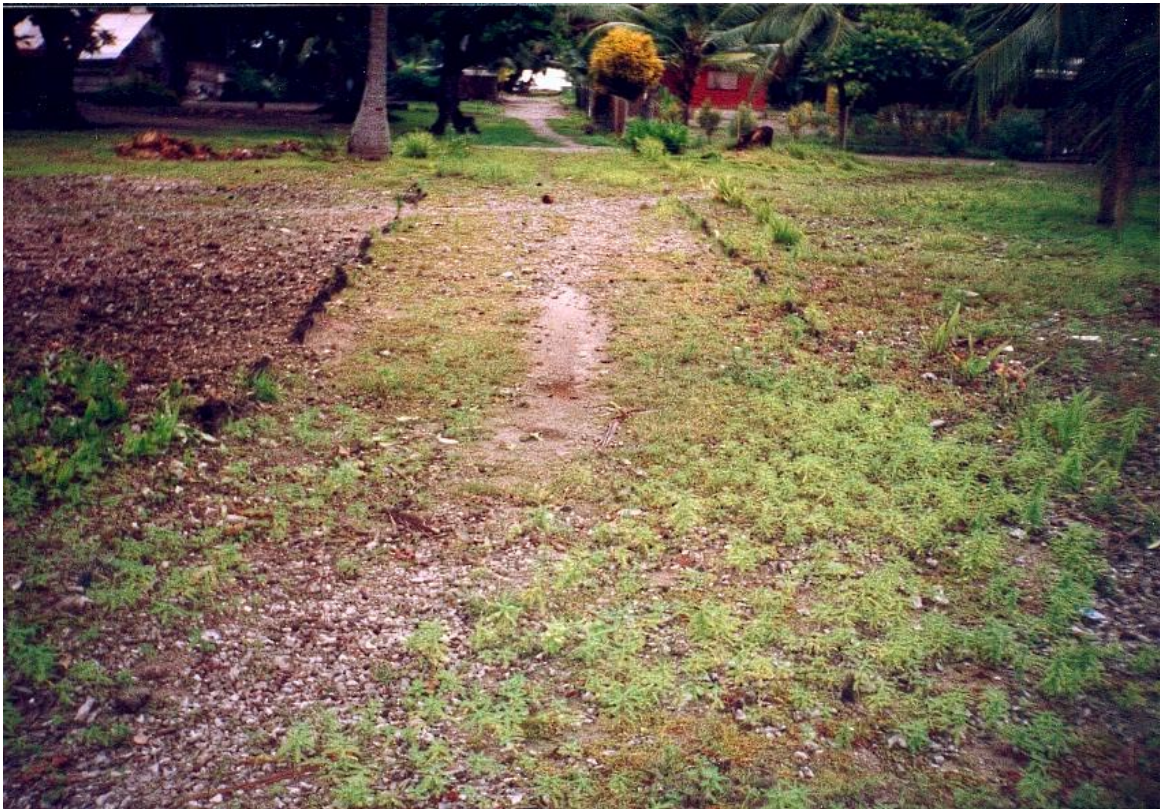
Figure 6 : Coral Path; Likiep Village, RMI. Facing east.

Likiep Cove is remarkably unchanged today and most of the coral paths and many buildings still exist. Figure 6, photographed almost 90 years after Joachim De Brum's photograph, shows one of the paths included in figure 5. Consideration of the two photographs illustrates a dramatic change in management practices that now permit grasses and other ground cover to grow freely on paths that were previously carefully raked and weeded.

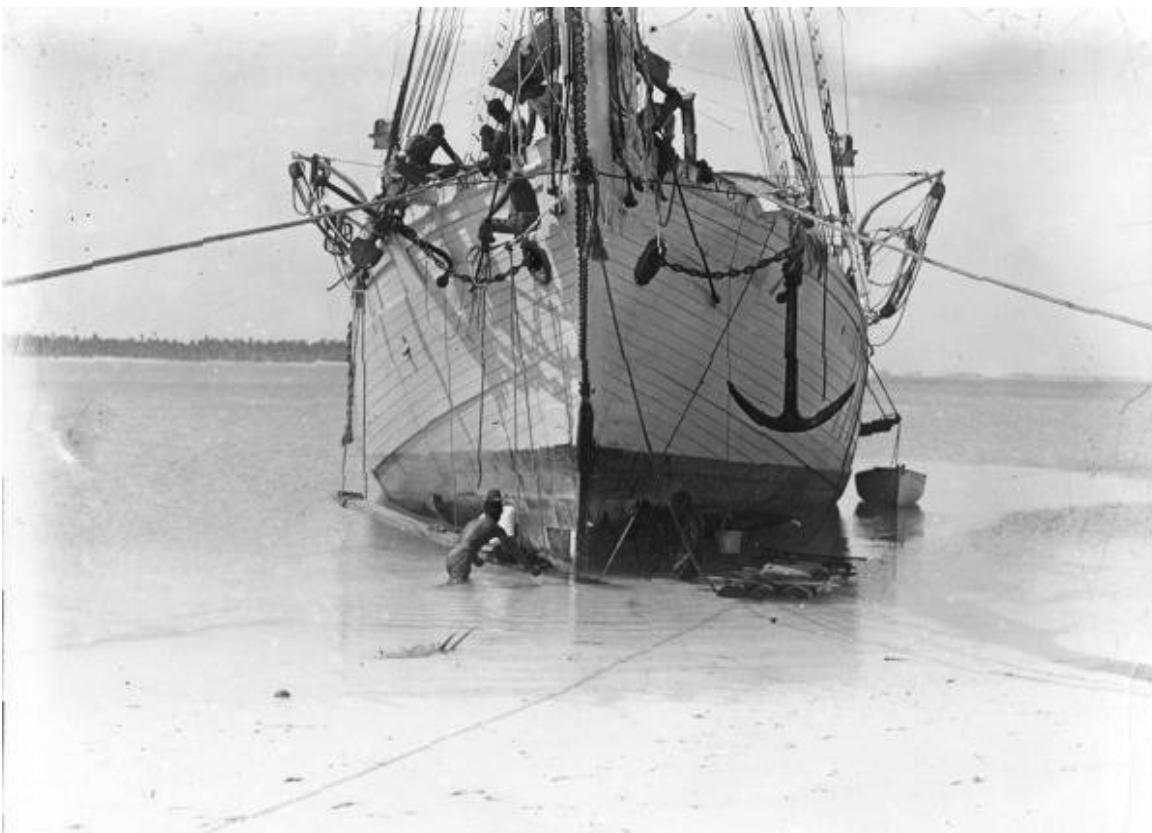
Figure 7 : Repairs to a Trading Vessel in Likiep Cove. Photo: De Brum Collection, Alele Museum, Majuro; with permission Leonard De Brum

Maintenance and construction of shipping developed into a second industry, and one that drew heavily on Marshallese tradition and skills (Figure 7). Under Joachim's energetic management, it contributed much to the continuing development on Likiep of revolutionary economic and social change.

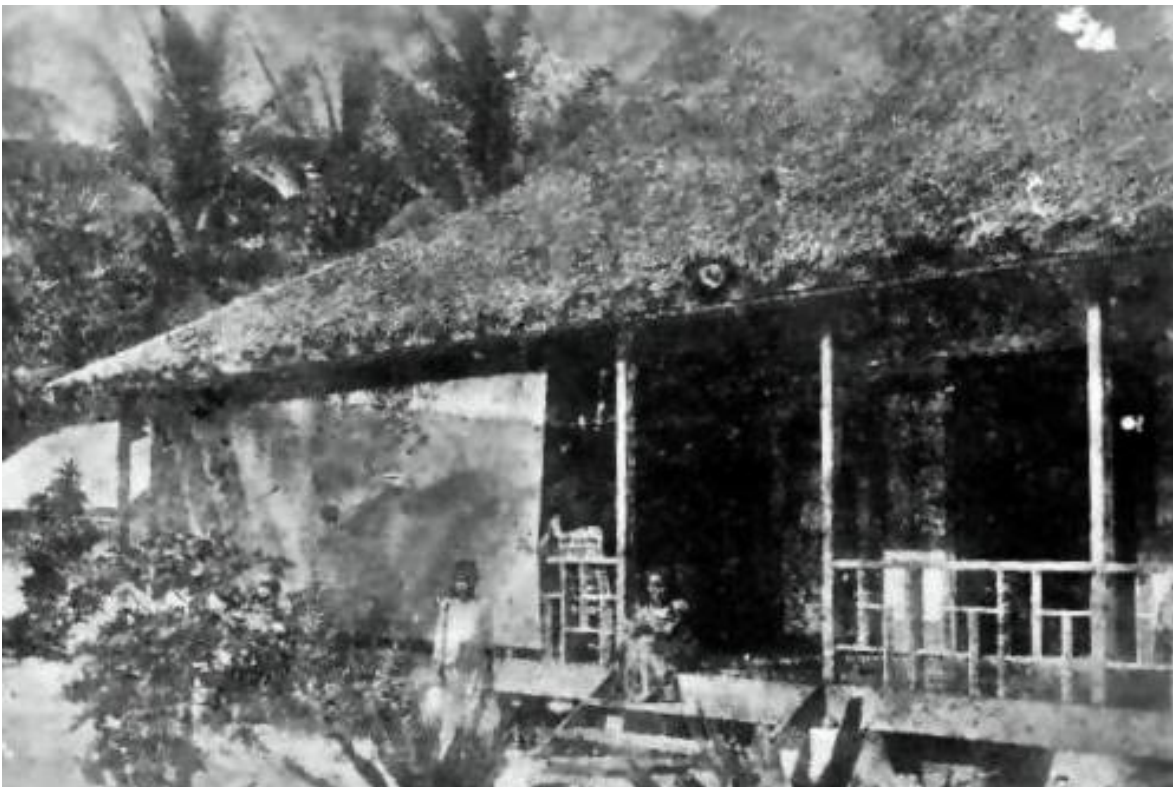
Figure 10 : Main House with Thatched Roof; c. 1910; Photo: De Brum Collection, Alele Museum, Majuro; with permission Leonard De Brum

Figure 10 shows the house in its original state, with short concrete piers, high thatch roof, and wide verandahs. Figure 11 shows the house after the thatched roof was removed and replaced with corrugated iron, but still standing on short concrete piers. Figure 12 shows the house as it was in 1999 after it had been raised on high wooden piers. They all show the western or lagoon-side of the house and illustrate the main stages in its evolution.

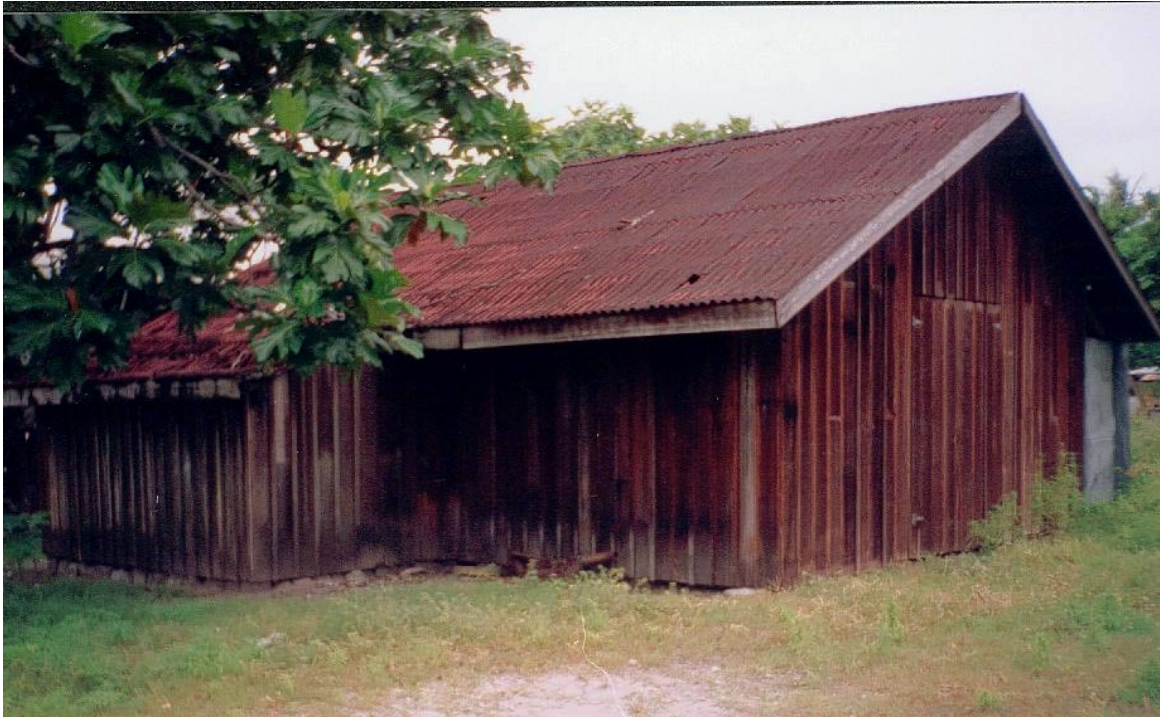
Figure 14 : Storage Shed; Likiep, RMI; facing northeast

The storage shed (Figure 14 & Figure 15) has large double doors at both the northern and southern end but no windows, and is situated several metres directly south of the main house. It contains many highly significant artefacts including shipwrights' tools, ships water barrels, lanterns, crockery and many other household items and tools of considerable historic and cultural value.

Jelks reported that both the walls and roof of this storage shed were originally built from corrugated iron (Jelks & Jelks 1978, pp. 9 & 12). This construction is also illustrated in photographs (Plates III and IV – 18 Oct 1983) in an undated report titled “Proposal for the Marshall Islands Development Project: The Joachim de Brum House Restoration Project.” However, the shed was largely rebuilt during the 1984 stabilisation project (Roberts 1984) and the roof and siding completely replaced. Rather than using corrugated iron, the roof was replaced with an asphalt-based roofing material and the sides with new redwood planks. The planks were fastened to the frame in a vertical overlapping fashion, a style that is not evident elsewhere on the island. Why such unusual and seemingly inappropriate materials and methods were used instead of following the original style and material (thus maintaining historical accuracy) is unknown.

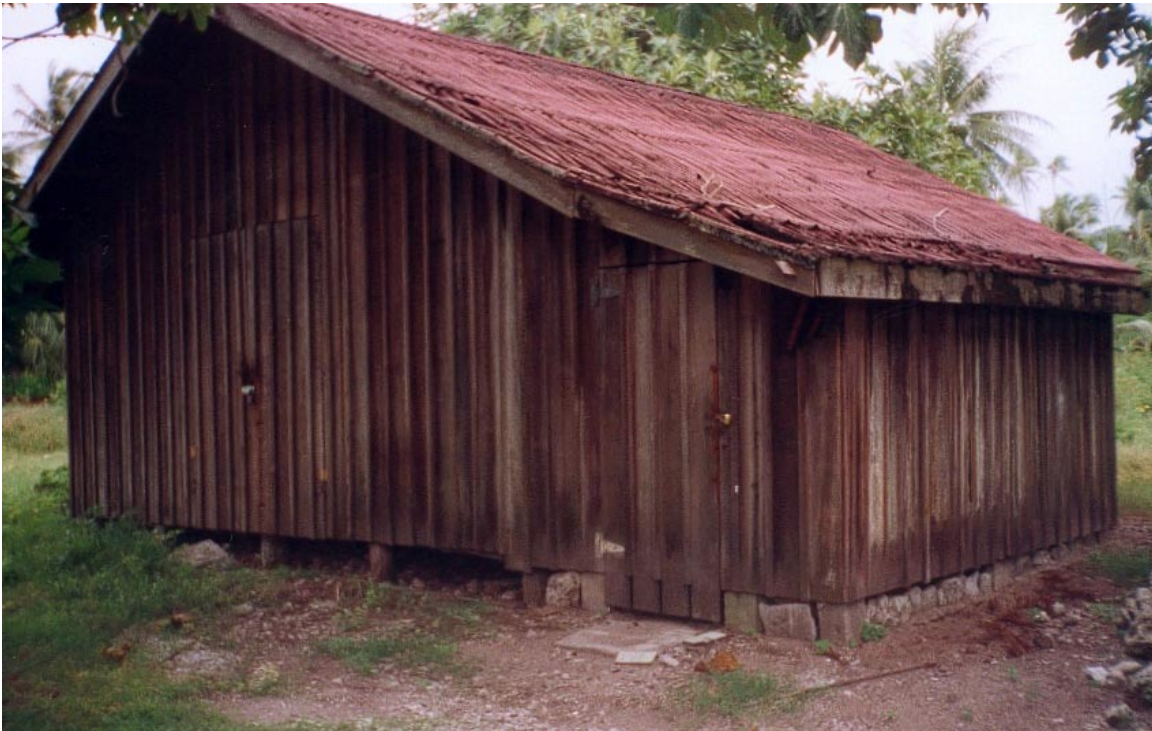
Despite its “25 year warranty” (Roberts 1984, p. 9) the new roofing material has been spectacularly unsuccessful (Figure 15). Of an asphalt composition, tropical conditions have softened it so that it now sags heavily between each roof support and several sections have torn or split under their own weight. Others have failed completely with several large holes permitting substantial water ingress. The timber walls have been damaged by termites, and floorboards and joists are substantially damaged by the combined effects of termites and rot.

Figure 15 : Storage Shed; Likiep, RMI; facing southeast and showing damaged roof.

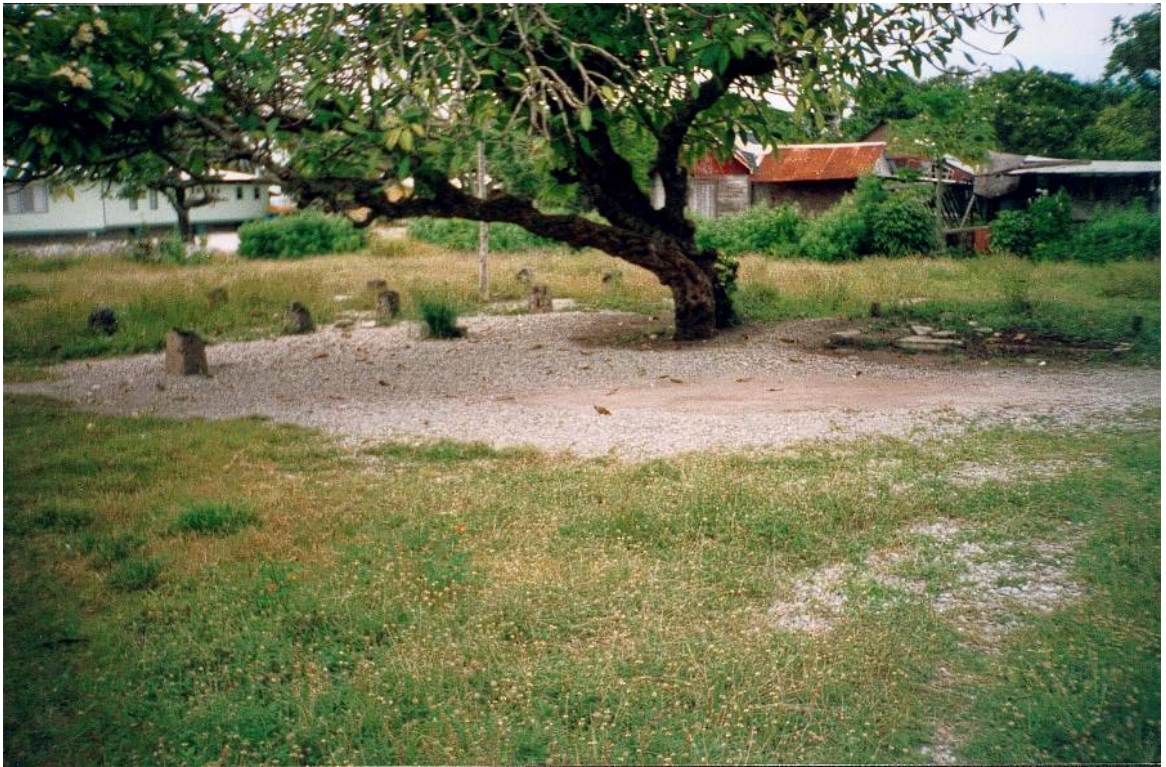
Figure 16 : Foundations of Raymond De Brum's House and Joachim's first Darkroom; Likiep, RMI; facing northwest

Ten metres northeast of the house are some remains of the foundations of a house built by Joachim for his eldest son Raymond (Figure 16). Unlike several other houses on Likiep, it was built on short concrete piers made from a mix of cement and crushed coral that now show the effects of salt induced decay. It is reported to have accidentally burned down in the 1920s (pers. comm. Leonard De Brum, October 1999). Elevation on short concrete piers was characteristic of Joachim De Brum's construction methods (US National Park Service 1984). The architectural style he usually employed was a combination of Germanic and Marshallese and incorporated a simple design of three rooms with surrounding verandas and an external kitchen and dining room. Decorated balusters, high ceilings and a high peaked roof were also characteristic.

Immediately behind these ruins to the west, and directly north of the northeastern corner of the main house are concrete foundations of Joachim's first photographic darkroom (Figure 16 & Figure 17).

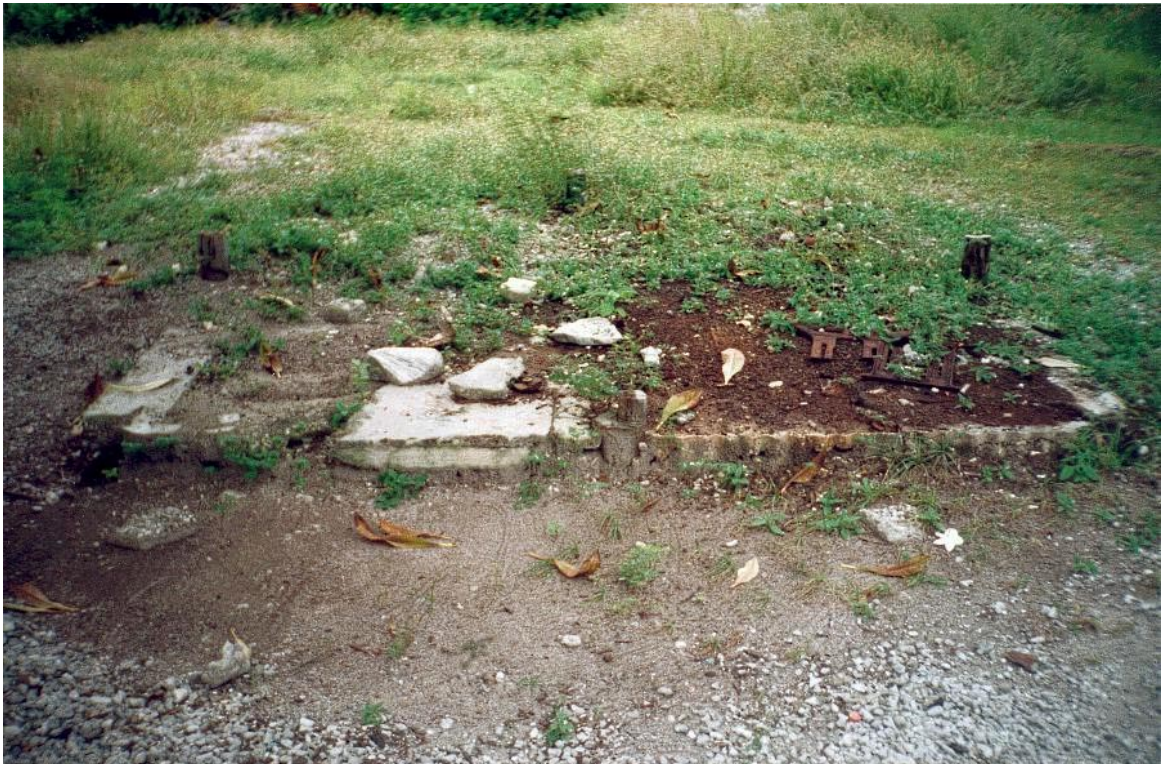
Figure 17 : Foundation of Joachim De Brum's First Dark Room; Likiep, RMI; facing north

At each corner of the darkroom, decayed remnants of the building's wooden corner posts are evident. It is reported that this darkroom was used for a short time only (Jelks & Jelks 1978) until a larger and cooler darkroom was constructed against the northern wall of the water cistern.
