***Conservation
Assessment of the
Joachim De Brum
House, Likiep Atoll,
Republic of the
Marshall Islands***

by
Jon O'Neill &
Dirk H.R. Spennemann

ALBURY 2000

This is Part III
pp. 39-56

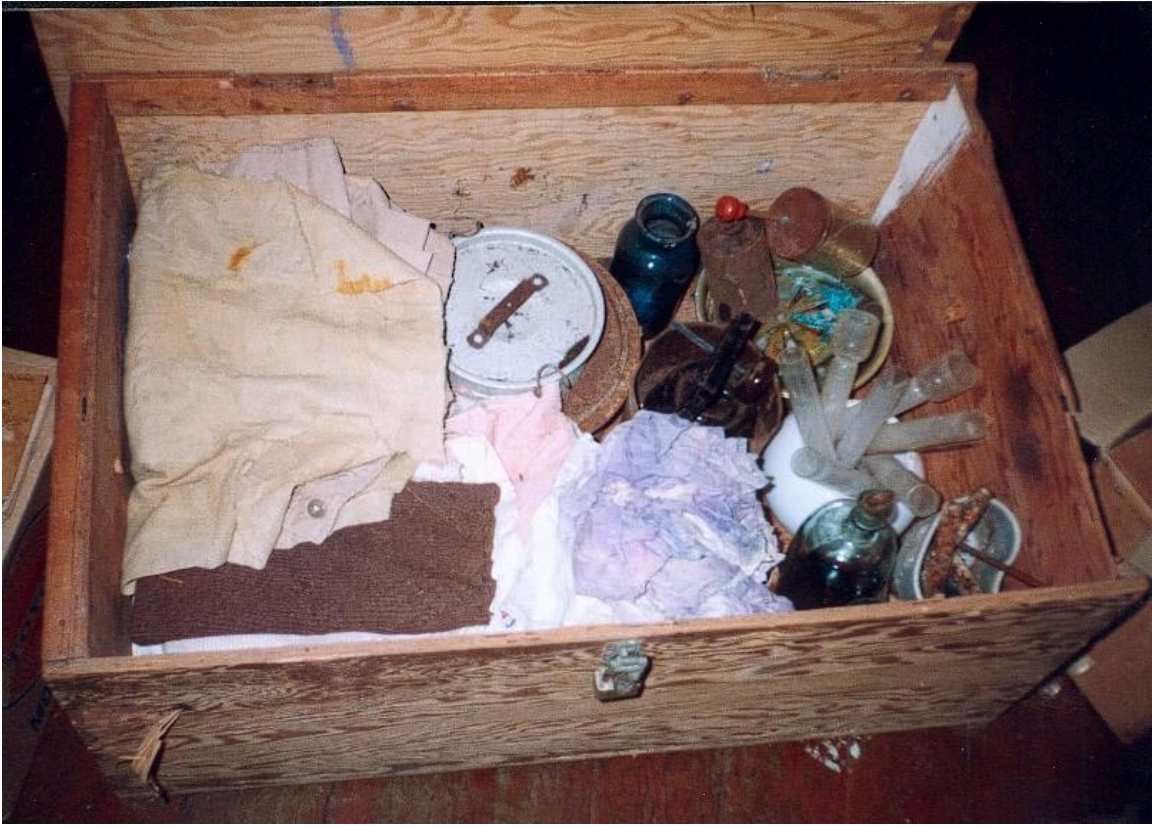
Figure 46 : Medical Chest; Joachim De Brum House, Likiep, RMI

an extraordinary range of subjects and is still regarded with profound respect by the inhabitants of Likiep. He studied medicine and dentistry, provided medical services to local communities (Figure 46), and established medical dispensaries on several islands at his own cost (pers. comm. Leonard De Brum, October 1999).

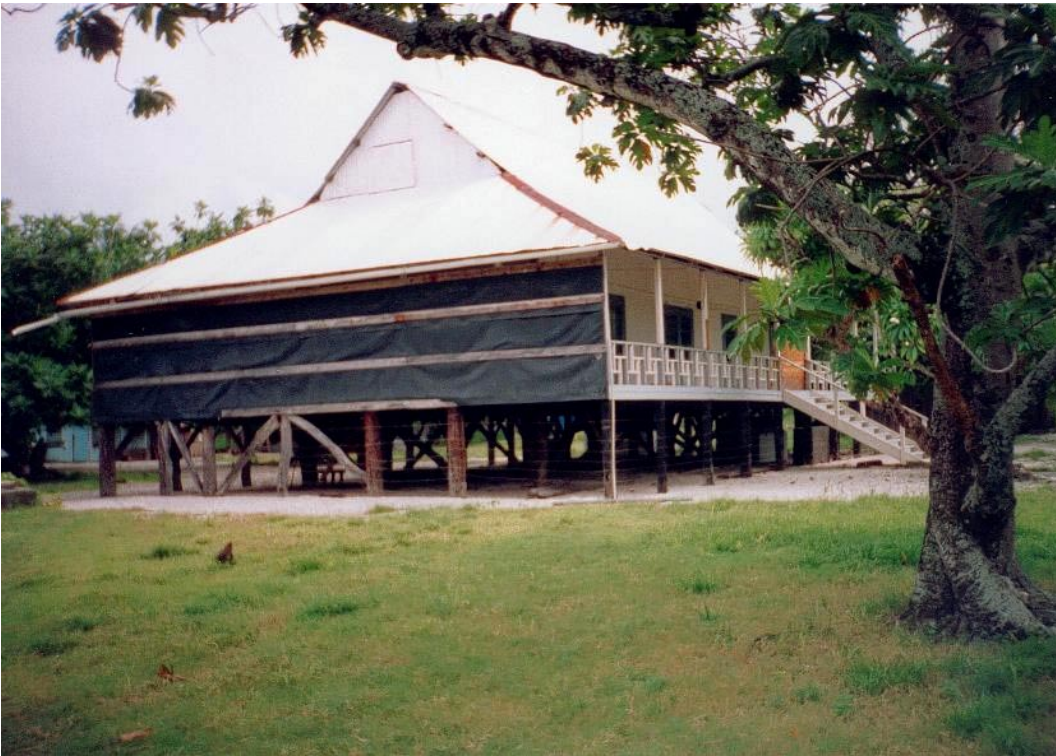
An attempt has been made to protect the northern veranda from weather by fastening a sheet of rubberised canvas extending the length of the veranda from roof to floor and to the fascia, handrail and floor (Figure 48). The southern veranda has a smaller section of the same material fastened from the western

Figure 48 : Rubberised Canvas on Northern Veranda; Joachim De Brum House, Likiep, RMI: Facing southeast

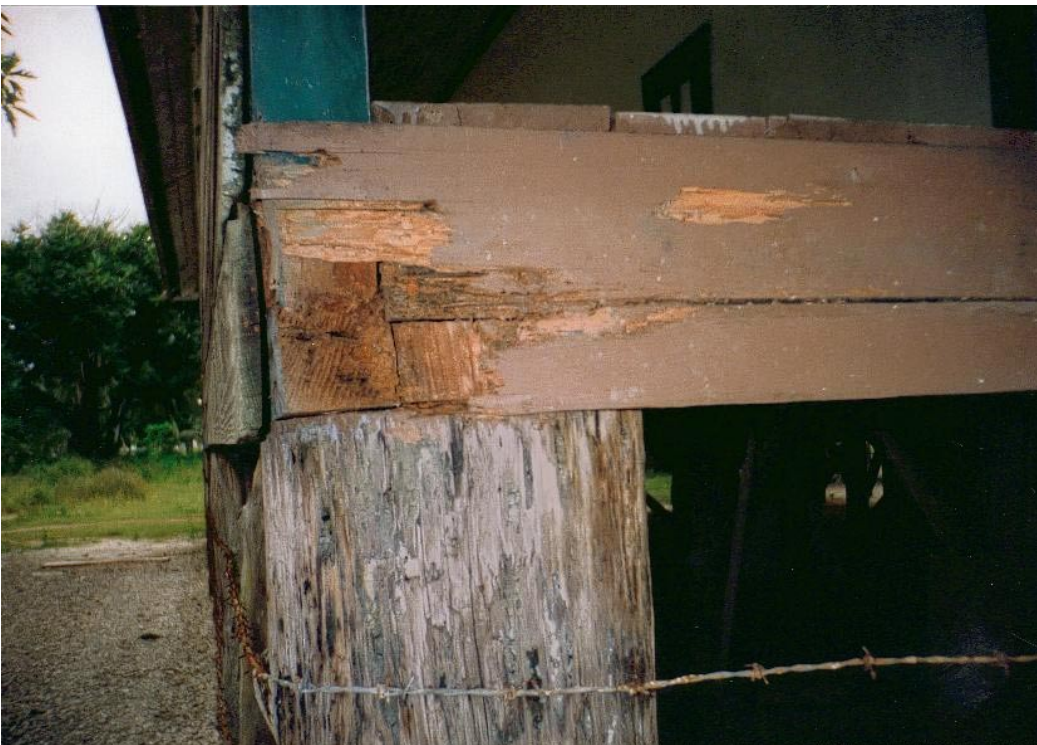
corner for approximately six metres and extending from the floor to the handrail. This well meant but misguided attempt to protect the veranda has had the opposite affect. Conditions were established where a micro-climate that is ideal for termite infestations could form, and the northern veranda is now infested for its entire length (Figure 49).

Figure 49 : Termite damage under rubberised canvas on north-eastern corner of veranda; Joachim De Brum House, Likiep, RMI: Facing south.

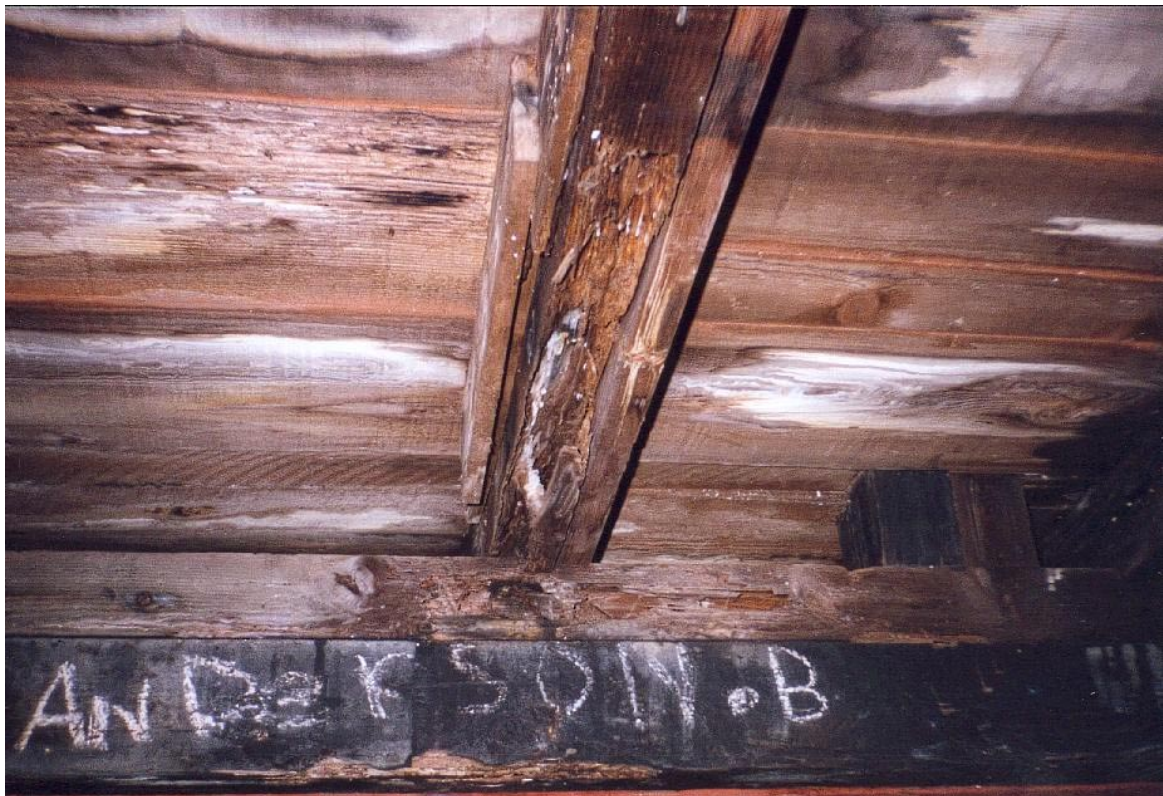
Many underfloor piers, joists and supports have decayed as would be expected after almost 100 years. Some were repaired in 1977 and 1984, but deterioration is continuing with water, insect and fungal damage, and graffiti evident on several timbers (Figure 52). A weathered house pier with a timber brace that can no longer support anything because of its extensive decay can be seen in Figure 47.

Figure 52 :Underfloor Decay and Graffiti; Joachim De Brum House, Likiep, RMI: Facing west

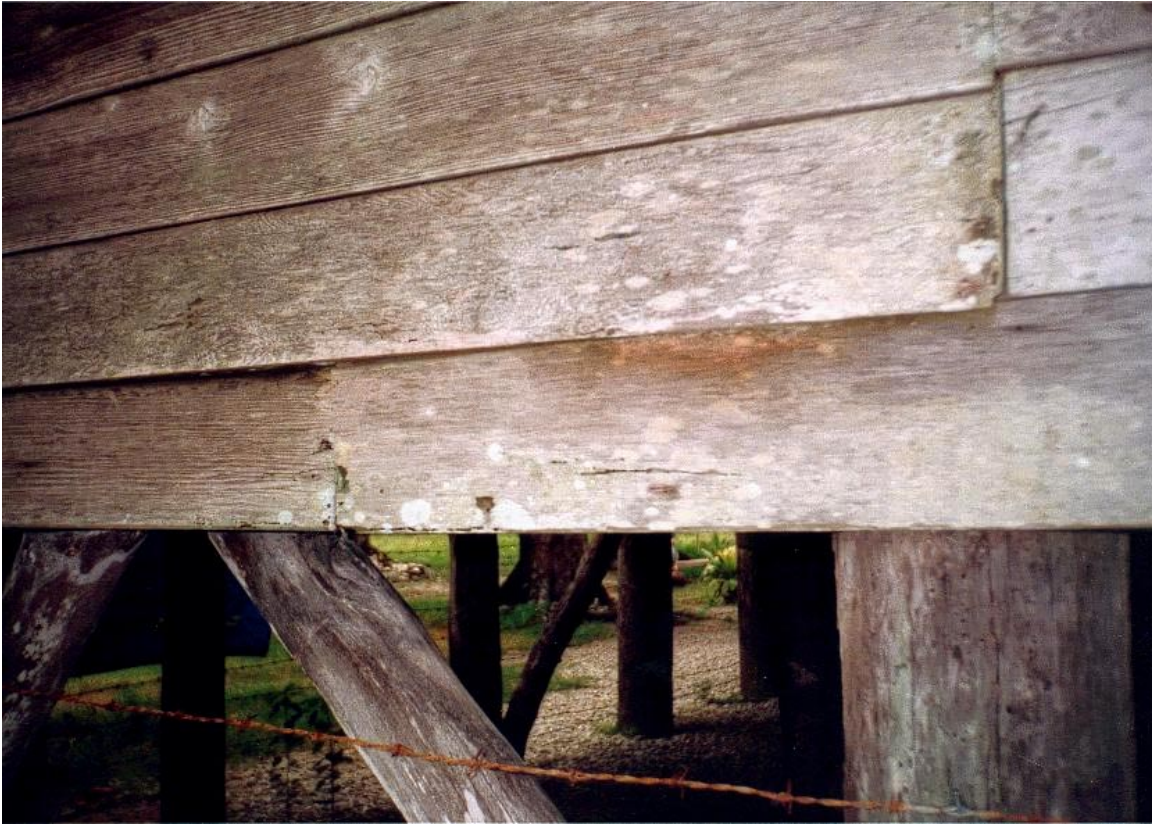
Paint is badly weathered, particularly on the eastern or weatherly side, where extensive areas of timber are now almost totally stripped of protection from the elements. Perusal of Figure 12 will clearly show the difference in paint quality between the leeward or western side of the house and the less-protected southern side. Figure 53 shows how constant trade winds have stripped paint from the eastern veranda wall leaving it unprotected.

The effect of weathering from a combination of direct sunshine and prevailing trade winds is illustrated in Figure 53 as veranda timbers that were once protected by paint have been stripped bare.

Figure 53 : Weathered veranda timbers; Joachim De Brum House, Likiep, RMI: Facing south-west
